Pan American Health Organisation
Christ Church, Barbados

Organisation of Eastern Caribbean States
Disaster Mitigation and Preparedness Project Office
The Morne, St Lucia

Vulnerability Assessment of the Restoration Works

Tony Gibbs
Consulting Engineers Partnership Ltd
"Concept", Dayrell's Road, Christ Church, Barbados

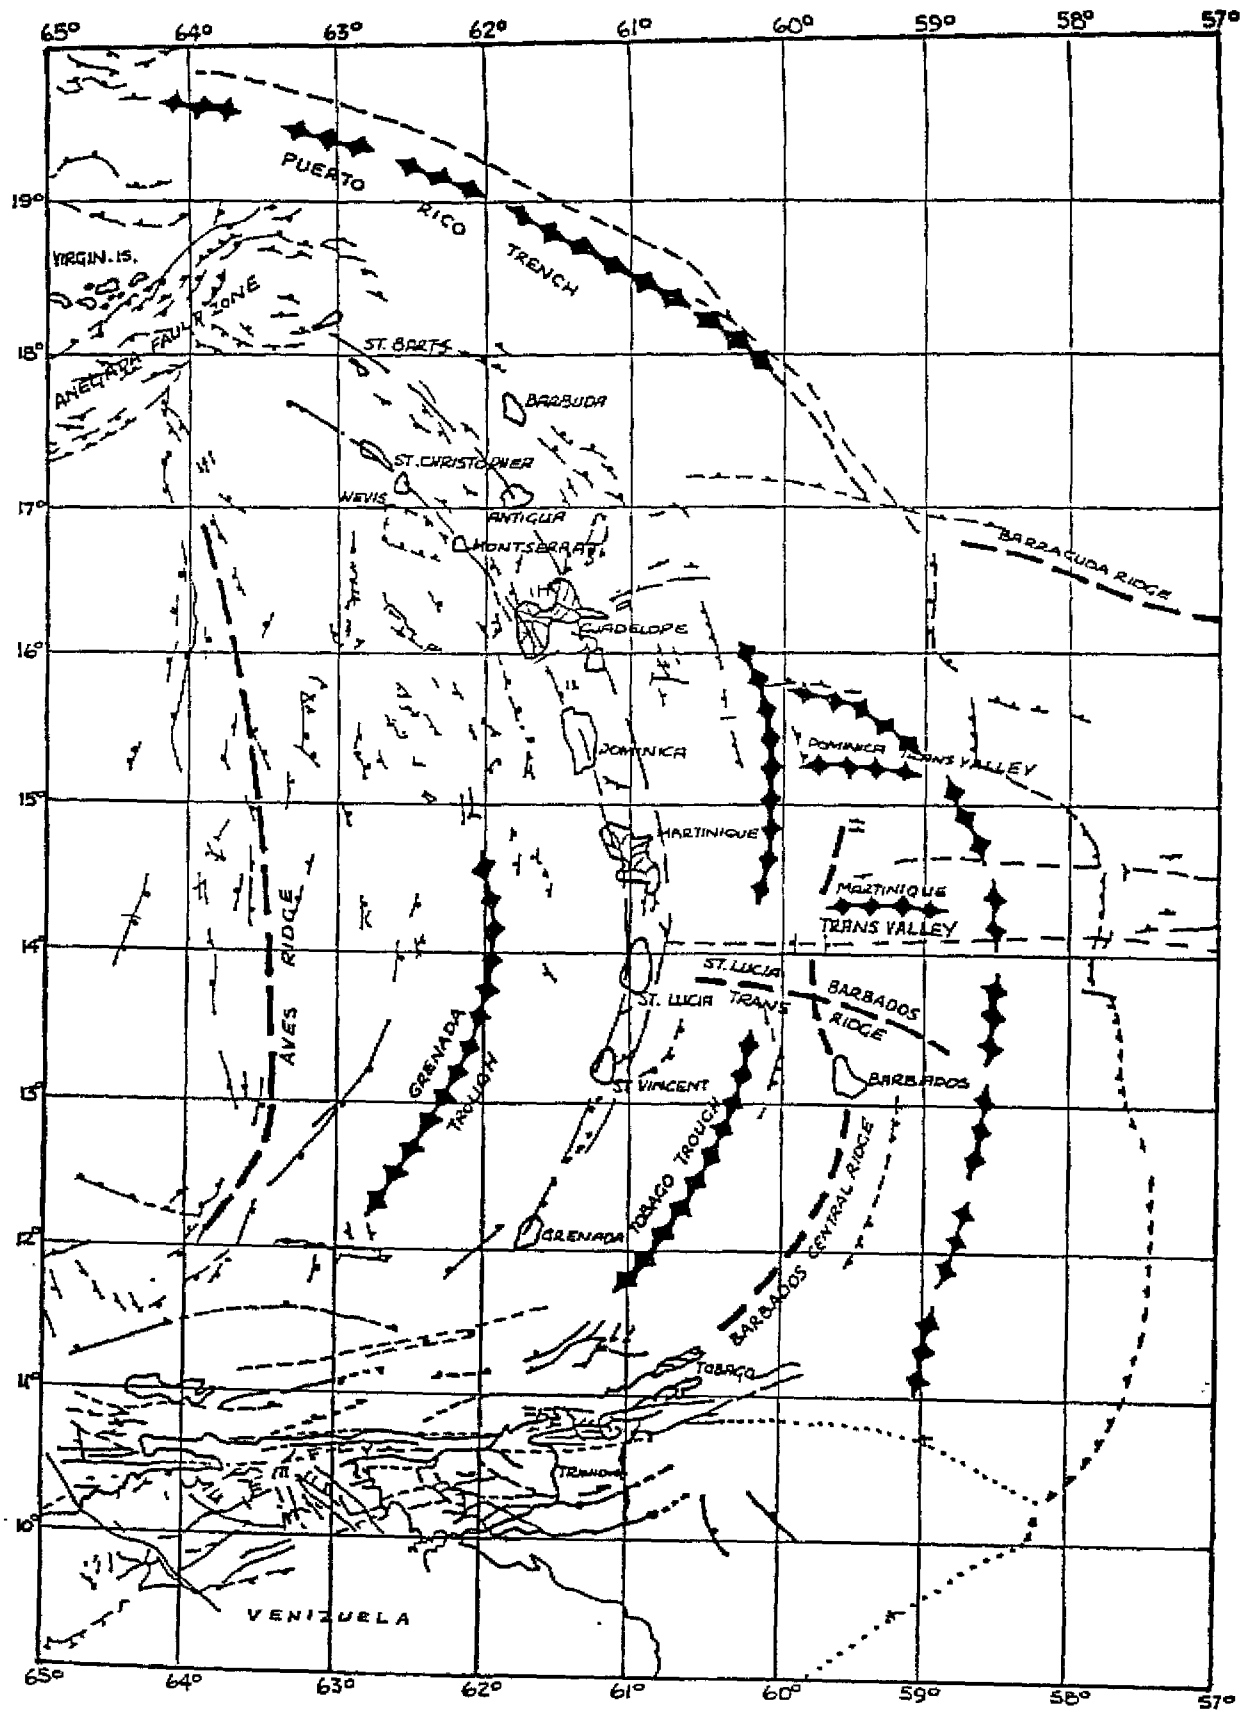
Figure 2

Main Features of Eastern Caribbean
 (based on compilation by JE Case and TA Holcomb USNOO
 and from Peter and Westbrook, 1976)

Figures 1, 2 and 3 (at the end of this sub-section) show the tectonic setting of the Caribbean, the main physical features of the Eastern Caribbean and a cross section through the island arc.

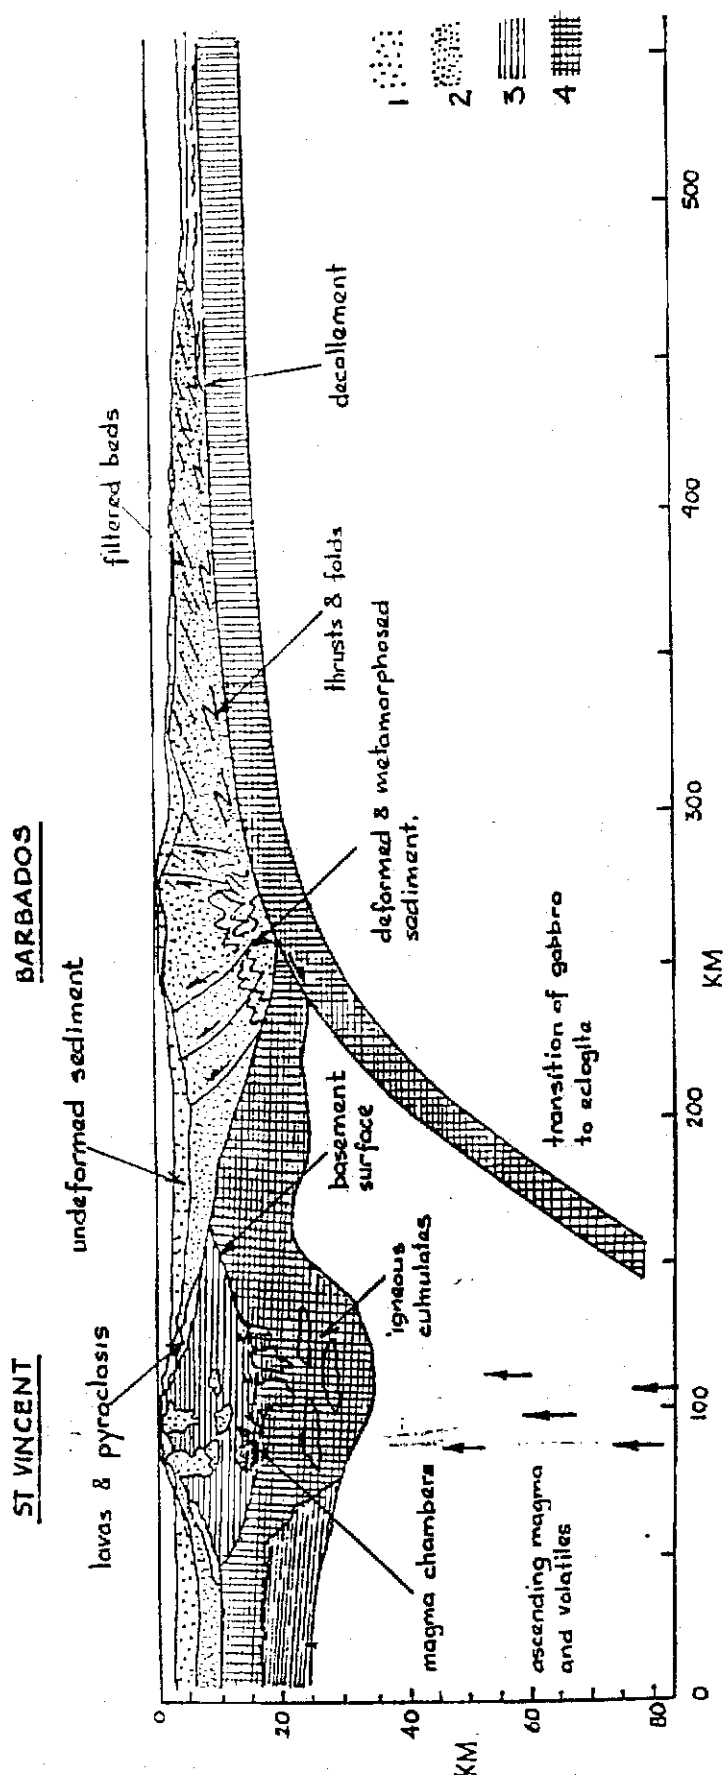
Diagrammatic cross-section of the Eastern Caribbean island arc illustrating the structure and the processes acting on it. 1. Undeformed sediment. 2. Deformed and/or consolidated sediment. 3. Igneous crust produced by the volcanic arc. 4. Main oceanic crustal layer and lower crust of arc. Vertical exaggeration 2:1.

Structure in Region of Barbados
(Westbrook, 1970)

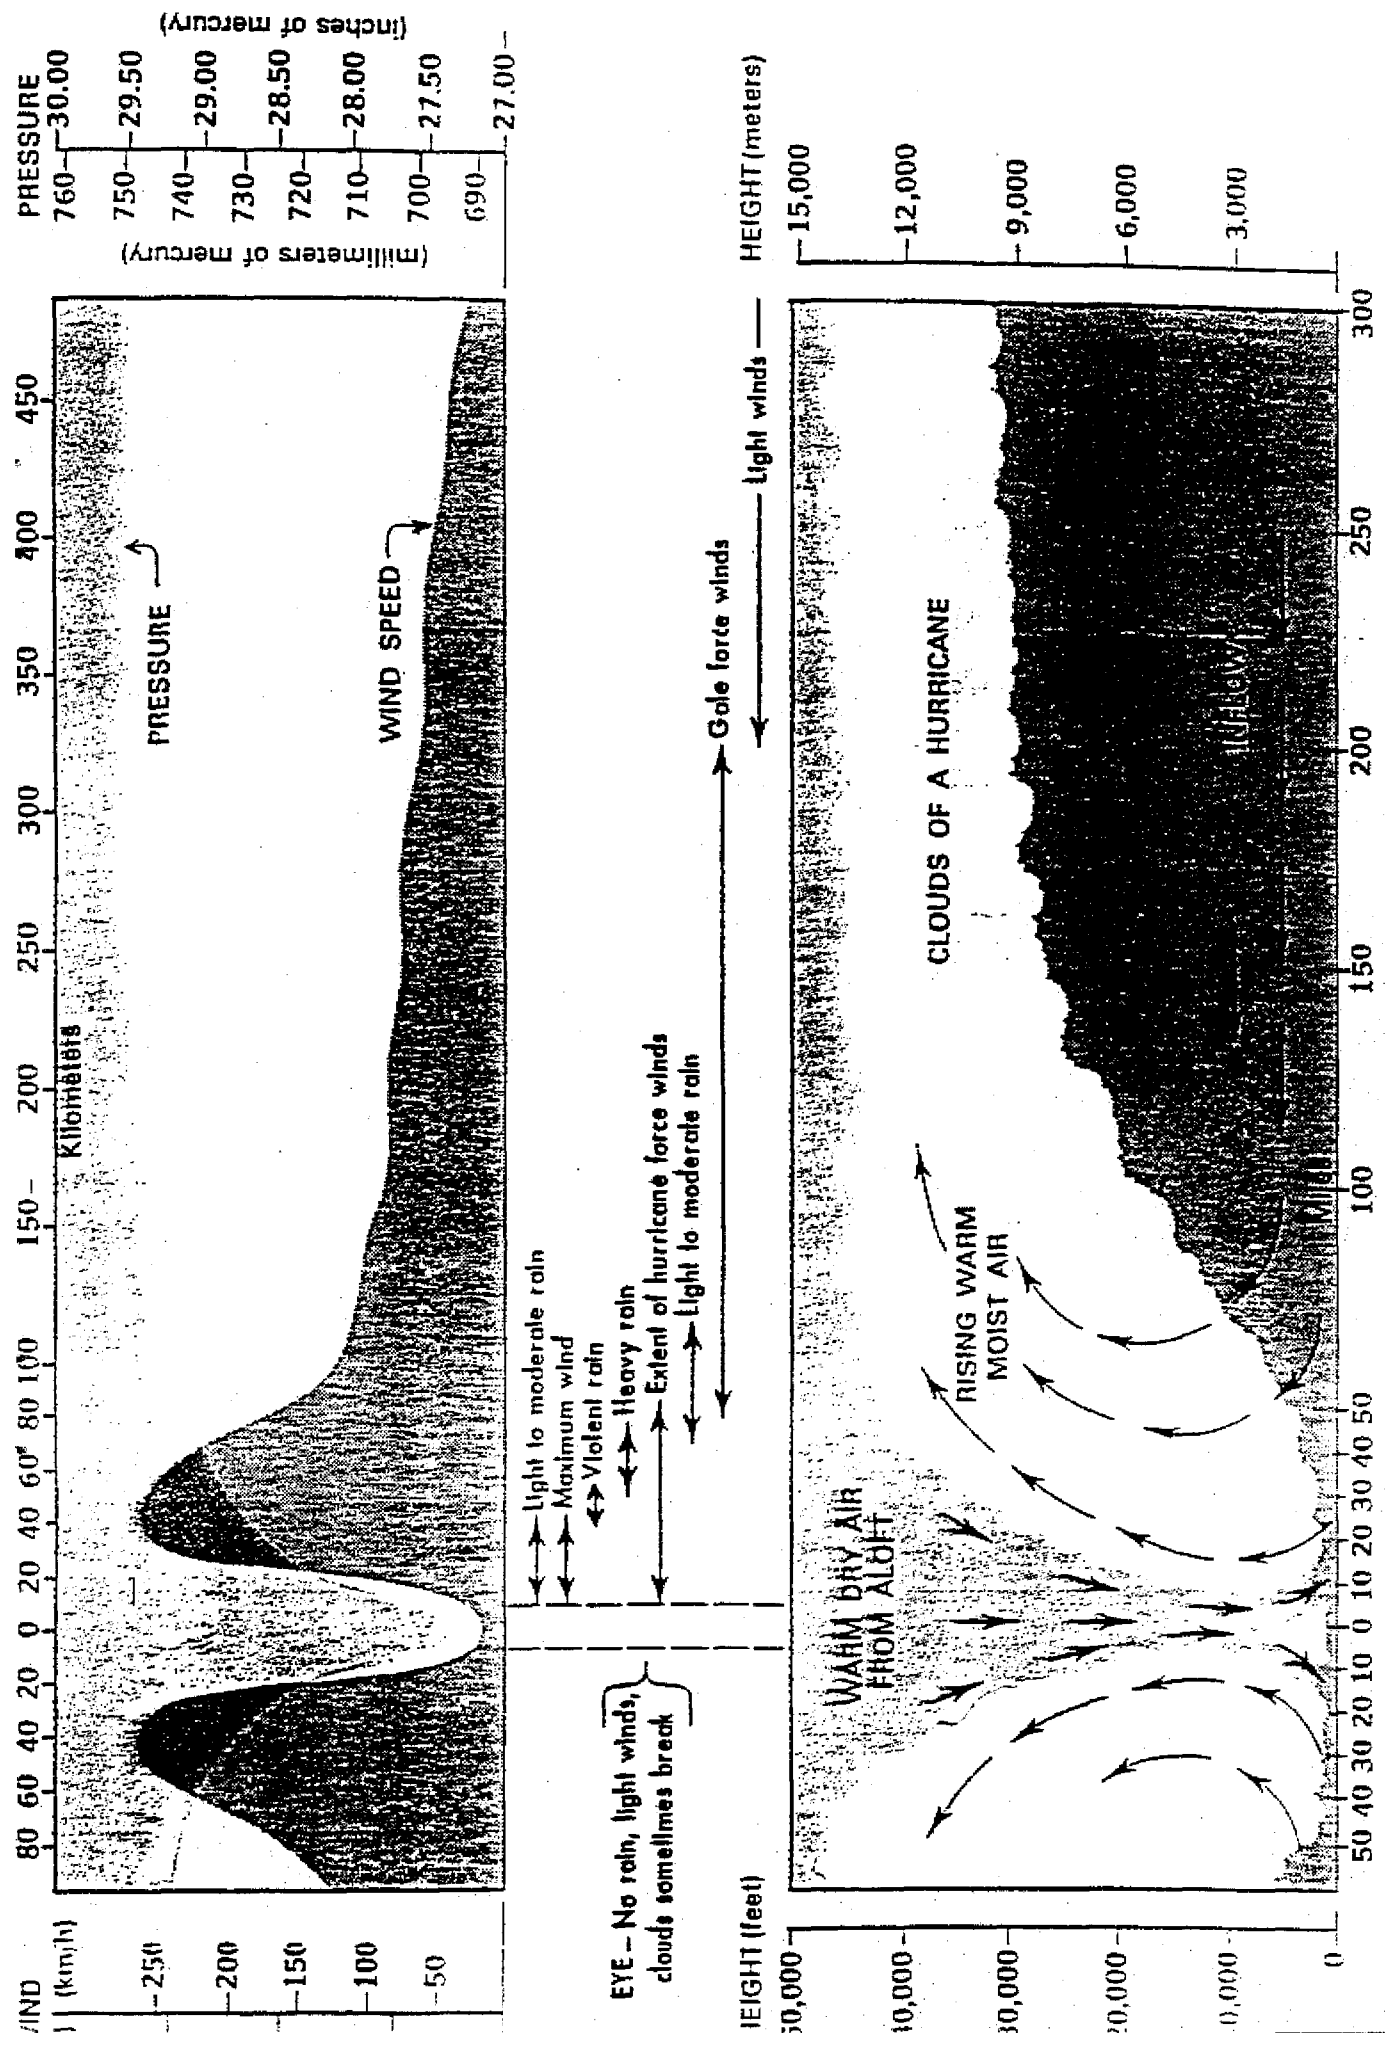
upper chart shows:
 Variations of Wind Speed and Barometric Pressure
 with distance from the eye of the hurricane

A unique feature of a hurricane is the eye. The system of revolving winds does not converge to a point, but becomes tangential to the wall of the eye at a radius of 8 to 12 km from the geometric centre of the disturbance. The eye is an area of light winds, thin cloud cover and the lowest barometric pressure. The eye provides a convenient frame of reference for the system and can be tracked with radar, aircraft or satellite. Figure 5 (at the end of this sub-section) shows the variations of wind speed and barometric pressure with distance from the eye of the hurricane.

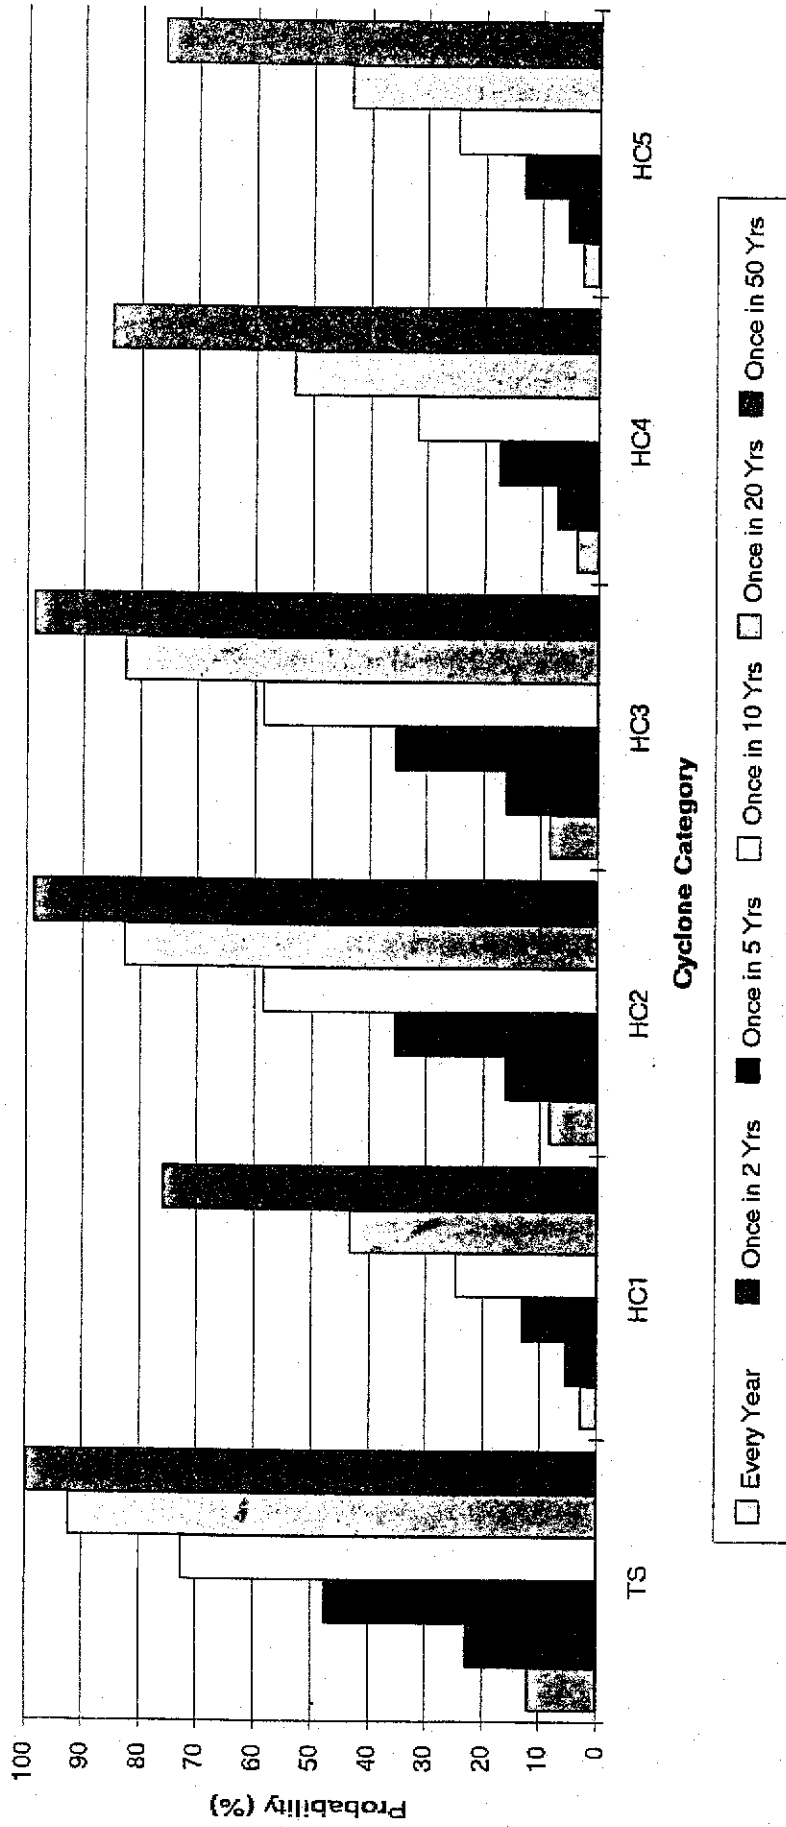
FIGURE 6

Cyclone Risk - Barbados

In Figures 6 and 7 (at the end of this sub-section) are presented a probability chart and table (CCRHP-UWI) of cyclone risk in a 2-degree square (approximately 220 km x 220 km) centred on Barbados. The statistics for St Lucia are not readily available but are likely to be very similar to those for Barbados. It is estimated that the probability of a direct hit on St Lucia is about 65% of the probability of a passage through the 2-degree square as shown on figures 6 and 7.

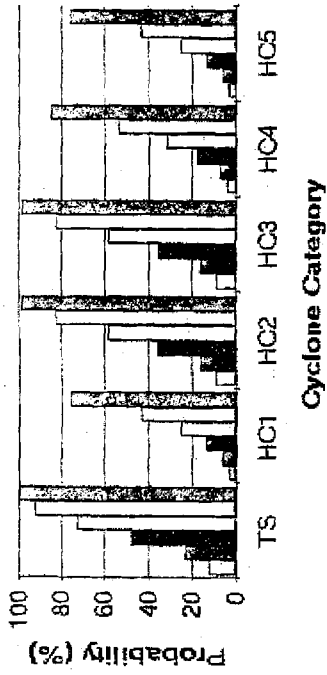
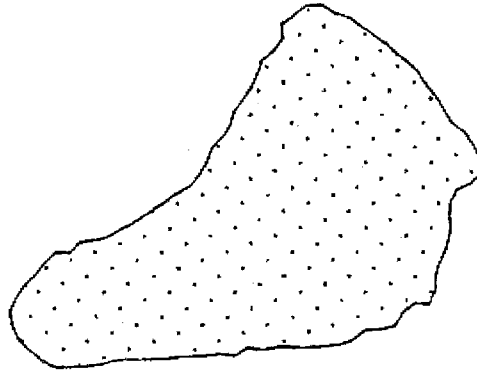
FIGURE 7

Cyclone Risk - Barbados

Number of Years	Probability of Cyclone (%)					
	TS	HC1	HC2	HC3	HC4	HC5
1	12	3	8	8	4	3
2	23	6	16	16	7	6
5	48	13	36	36	17	13
10	73	25	58	58	32	25
20	93	43	83	83	53	43
50	100	76	99	99	85	76

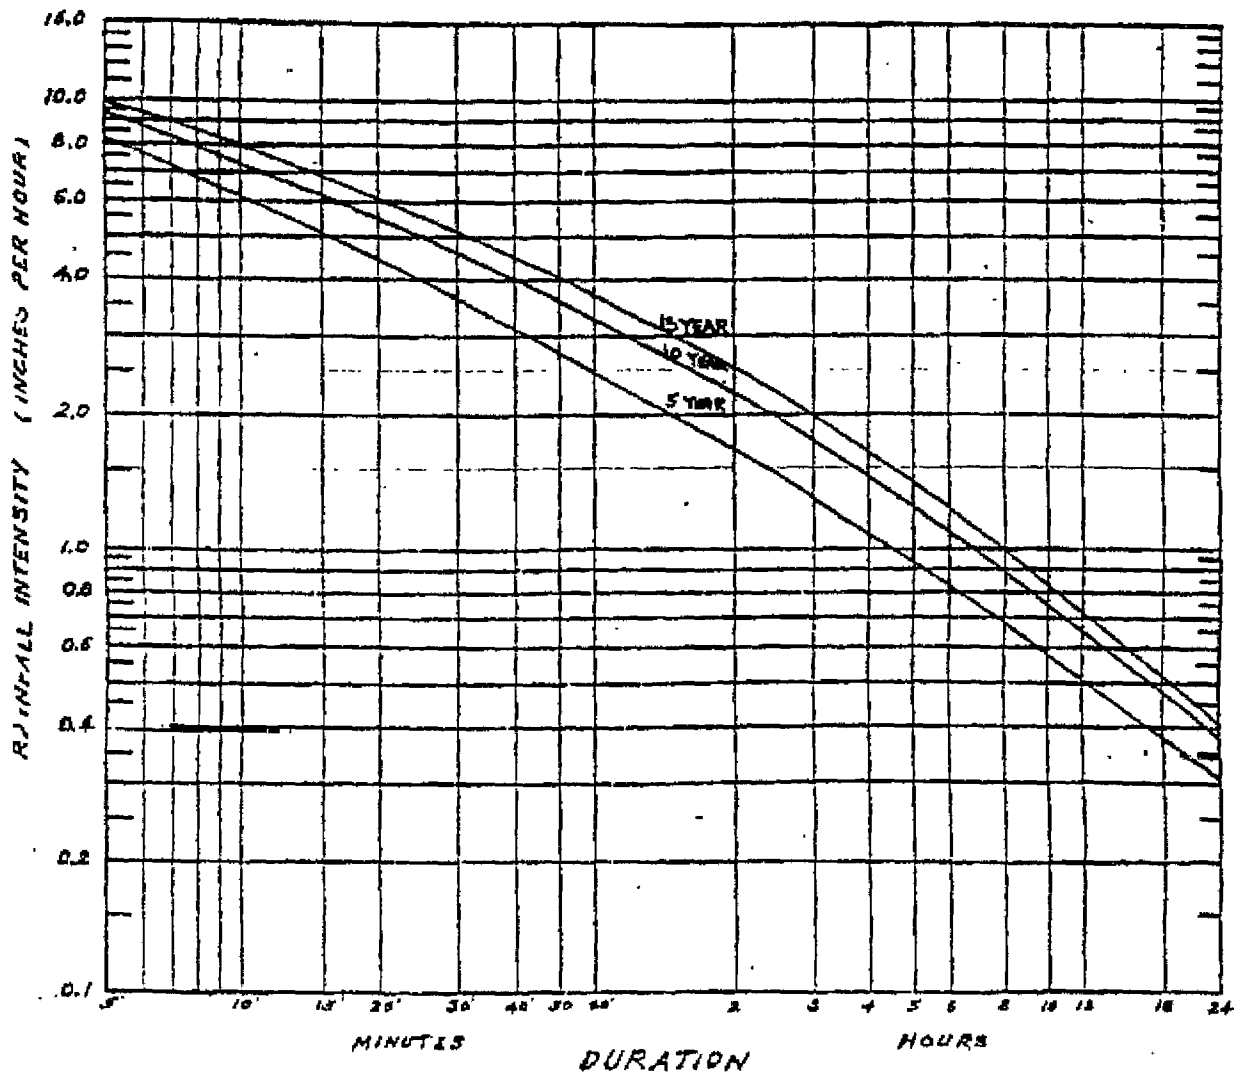
RAINFALL INTENSITY-DURATION FREQUENCY CURVES

UNION

Drainage systems and structures in St Lucia are generally designed for rainfall events having return periods of 20 years. This means that such systems are likely to become overloaded and cause some degree of flooding when rainstorms are experienced with return periods greater than 20 years. Figure 8 and 9 (at the end of this sub-section) show the rainfall intensity-duration-frequency curves for two locations in St Lucia.

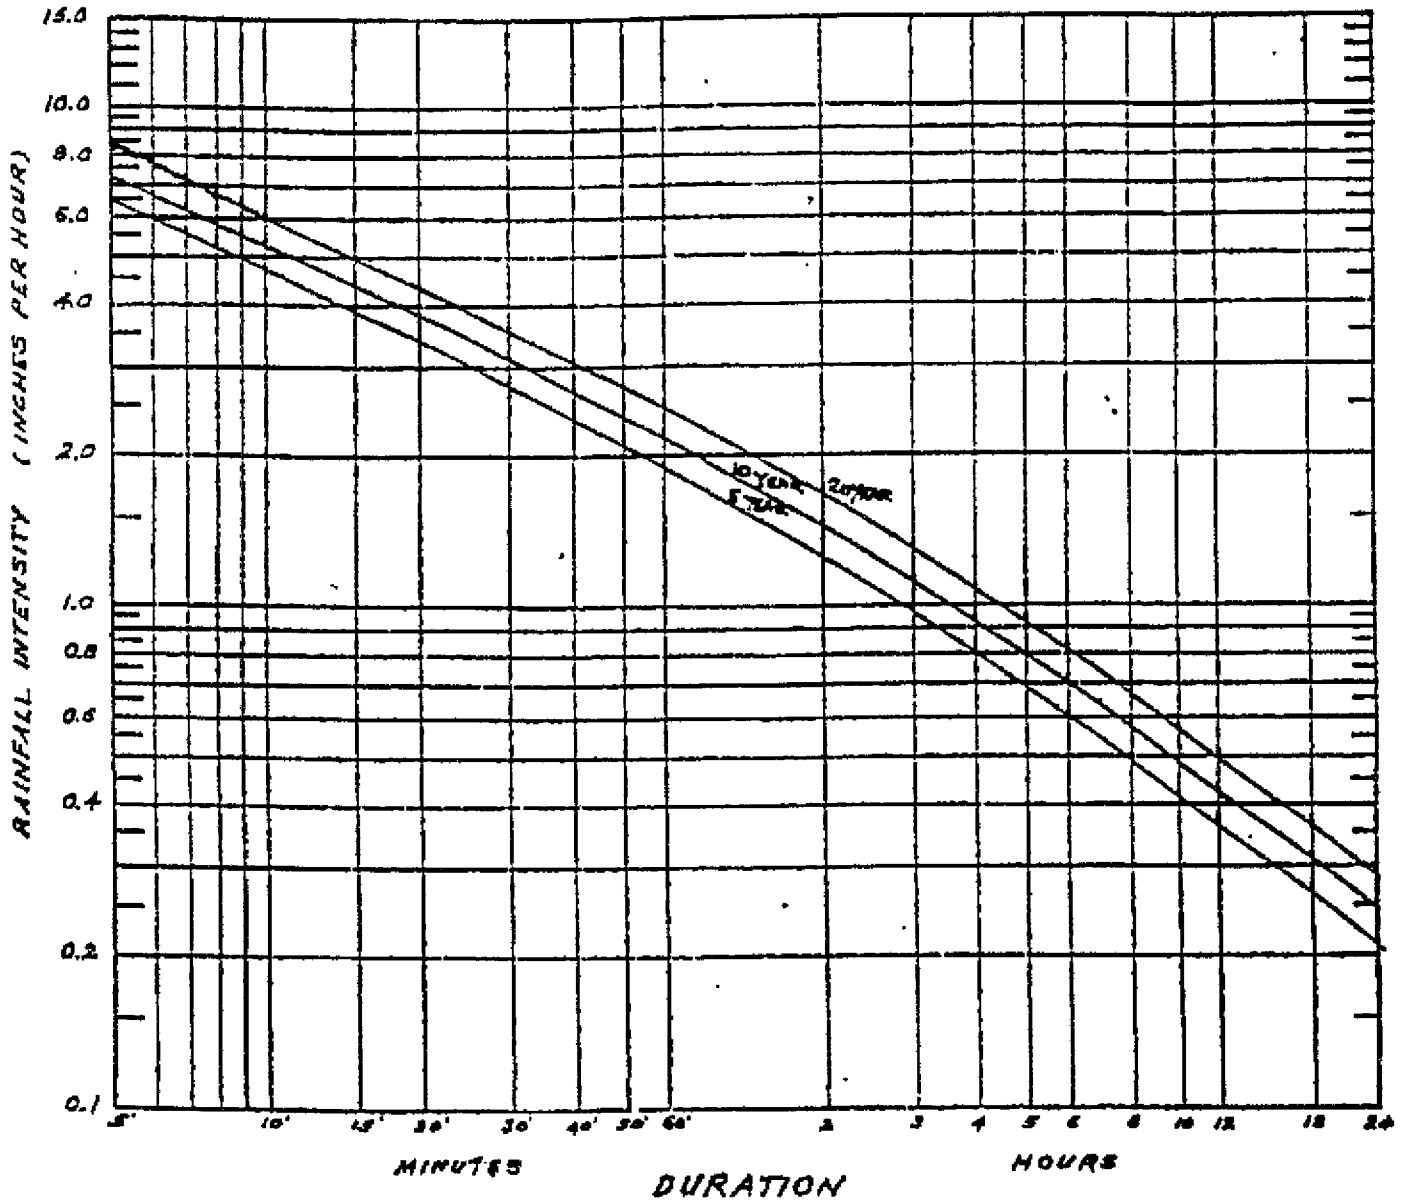
Figure 9

RAINFALL INTENSITY-DURATION FREQUENCY CURVES

LA PERLE, SOUFRIERE,
ST. LUCIA
